LRAPP VERTICAL ARRAY. PHASE II

C. H. Jones

Westinghouse Electric Corporation

REPORT DOCUMENTATION PAGE		READ INSTRUCTIONS BEFORE COMPLETING FORM
1. REPORT NUMBER	2. GOVT ACCESSION NO.	3. RECIPIENT'S CATALOG NUMBER
4. TITLE (and Subtitle) LRAPP VERTICAL ARRAY - PHASE II		5. TYPE OF REPORT & PERIOD COVERED Technical Report Feb. 12, 1972 to March 31, 1973

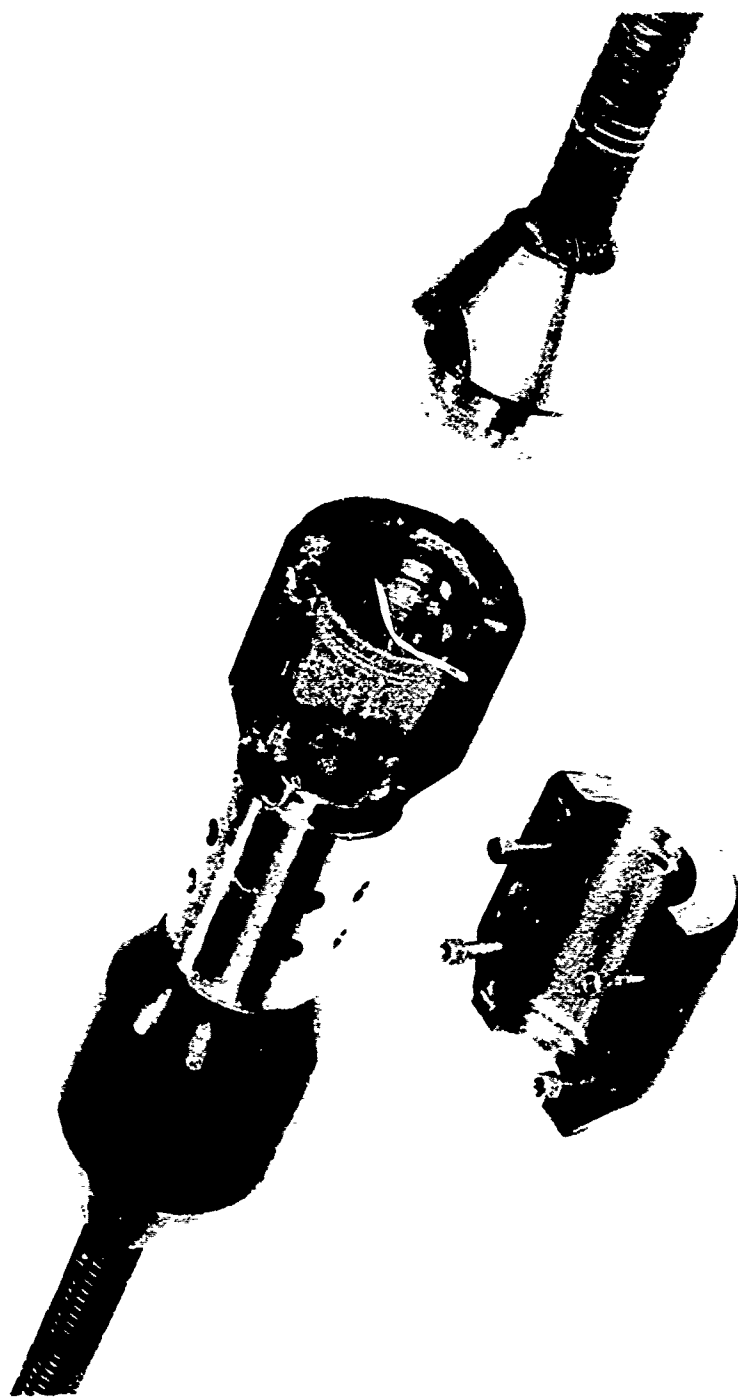
Fig. 7 - A Hydrophone with Split-Couplers at Each End for Attachment to the Cable

The 1/8" diameter pins on the hydrophones and on the cable terminations were used to properly orient the connectors. Roll pins were initially used but they often were broken during the assembly of the split-couplers so solid pins are now used. Figure 7 shows a hydrophone with split-couplers on each end for attaching it to cable sections. The cable lengths used in the 1972 deployment are shown in Fig. 8. One spare set of cables were manufactured.
